DEPARTMENT OF TRANSPORTATION**DIVISION OF ENGINEERING SERVICES**

Contract #: 04-0120F4Cty: SF/ALA Rte: 80 PM: 13.2/13.9File #: 69.28**WELDING INSPECTION REPORT****Resident Engineer:** Pursell, Gary**Address:** 333 Burma Road**City:** Oakland, CA 94607**Report No:** WIR-004620**Date Inspected:** 12-Nov-2008**Project Name:** SAS Superstructure**OSM Arrival Time:** 630**Prime Contractor:** American Bridge/Fluor Enterprises, a JV**OSM Departure Time:** 1430**Contractor:** Zhenhua Port Machinery Company, Ltd (ZPMC), Changxing Island **Location:** Shanghai, China**CWI Name:** Sun Wei / Sun Bo**CWI Present:** Yes No**Inspected CWI report:** Yes No N/A**Rod Oven in Use:** Yes No N/A**Electrode to specification:** Yes No N/A**Weld Procedures Followed:** Yes No N/A**Qualified Welders:** Yes No N/A**Verified Joint Fit-up:** Yes No N/A**Approved Drawings:** Yes No N/A**Approved WPS:** Yes No N/A**Delayed / Cancelled:** Yes No N/A**Bridge No:** 34-0006**Component:** OBG Deck Panels**Summary of Items Observed:**

Bay 3 – New Tower Shop**Visual Testing After Repair**

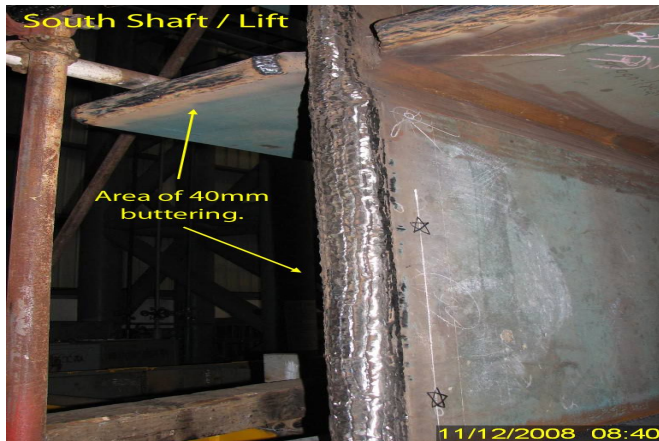
This QA Inspector observed ZPMC welding personnel performing Flux Core Arc Welding (FCAW) build up or buttering of longitudinal stiffener plate and skin plate bottom edges on South Shaft / Lift 1 to a thickness of 40mm.

In process FCAW not appear to comply with Caltrans Engineer approved buttering procedure which allows 20mm maximum build up.
